Durable Solution Against Abrasion in Production Facilities: Pexgol at YPF

Performance evaluation of Pexgol lining under extreme service conditions.

YPF
Argentina | 2018

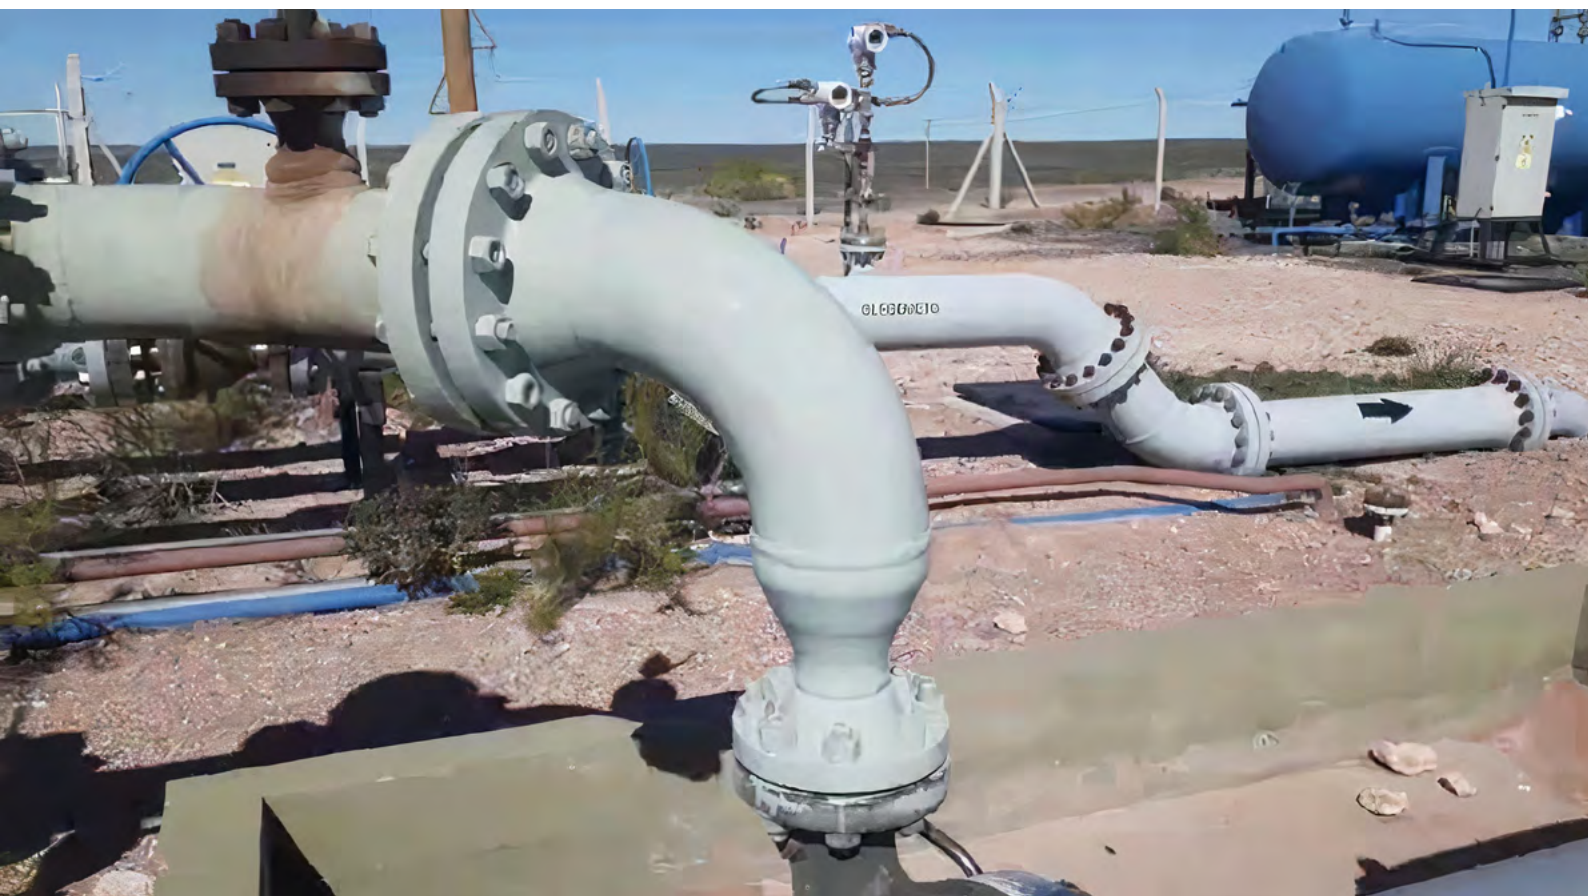
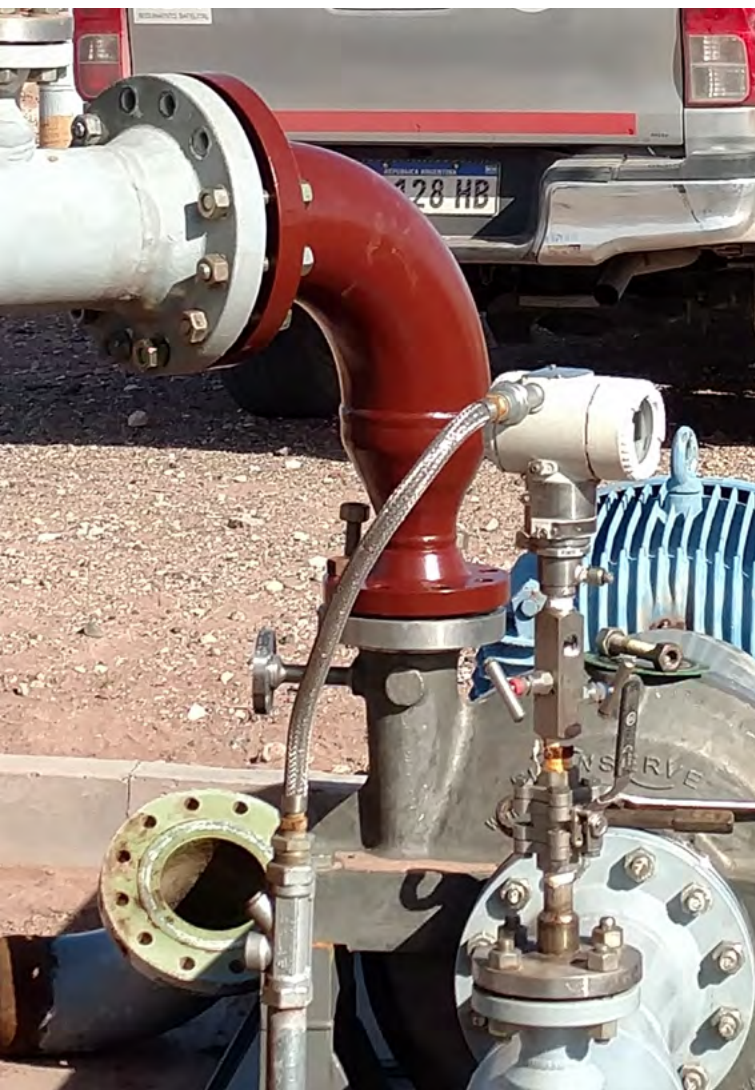
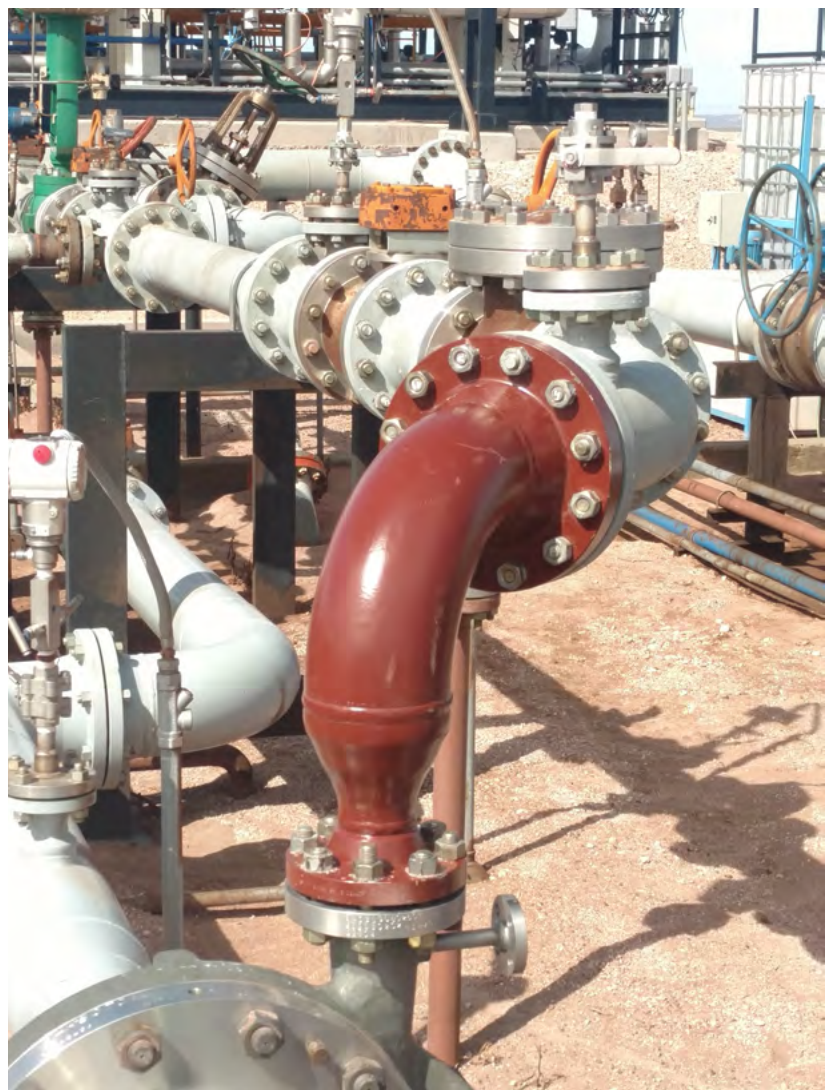
To mitigate the issue, YPF proposed testing a carbon steel component internally lined with Pexgol to assess its performance under real operating conditions. A 6" x 3" reducing elbow connected to the discharge of one of the pumps was selected for this trial.

The component was manufactured and inspected at Golan's facility, where the internal Pexgol lining was applied. Once installed and put into operation, the elbow remained in service for 7 years without damage, despite the severe operating conditions.
