Goodbye Asbestos: Pexgol Modernizes Thermal Water Network

850 Meters of Pipe Replaced in Less Than 24 Hours, Without Affecting Residents.

Raquet Club Lake Chapala Mexico | 2024

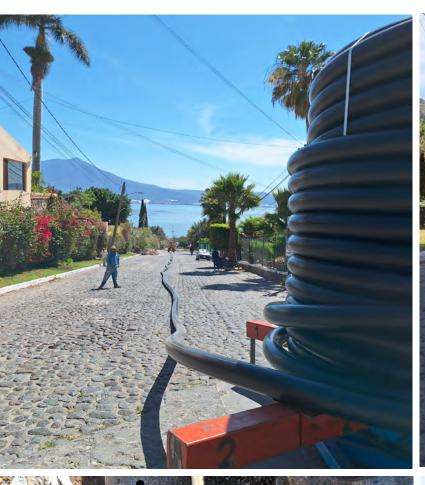
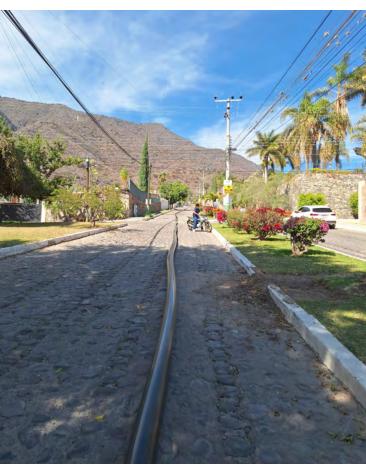
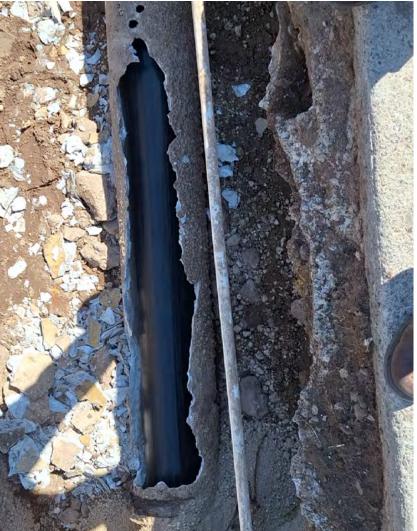
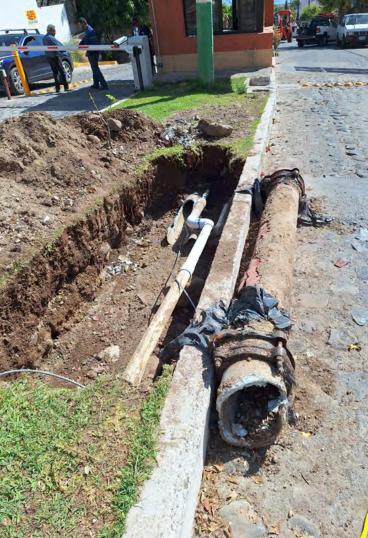
How was this achieved? By using the existing asbestos pipe as a guiding duct, the new Pexgol line was pulled through the entire route with a steel cable, eliminating the need for excavations. Thanks to its abrasion resistance and high flexibility, Pexgol withstood the pulling process without compromising its integrity. In addition, its ultrasmooth inner surface (roughness 0.0006 mm) allowed maintaining the original flow rate despite the pipe's smaller internal diameter, optimizing hydraulic performance.

The installation was carried out using flanged couplings, without welding or complex works. Although the contractor had no prior experience with this system, Pexgol's technical team provided full support: maneuver selection, staff training, and detailed planning. The result was a fast, clean, and safe implementation—without causing inconvenience to residents.
